**WATER DAMAGE TO
ASPHALT OVERLAYS:
CASE HISTORIES**

**Prithvi S. Kandhal
Carl W. Lubold, Jr.
Freddy L. Roberts**

**Presented at the Annual Meeting of the Association of Asphalt
Paving Technologists in Nashville, Tennessee, February 20-22, 1989.**

NCAT Report No. 89-1

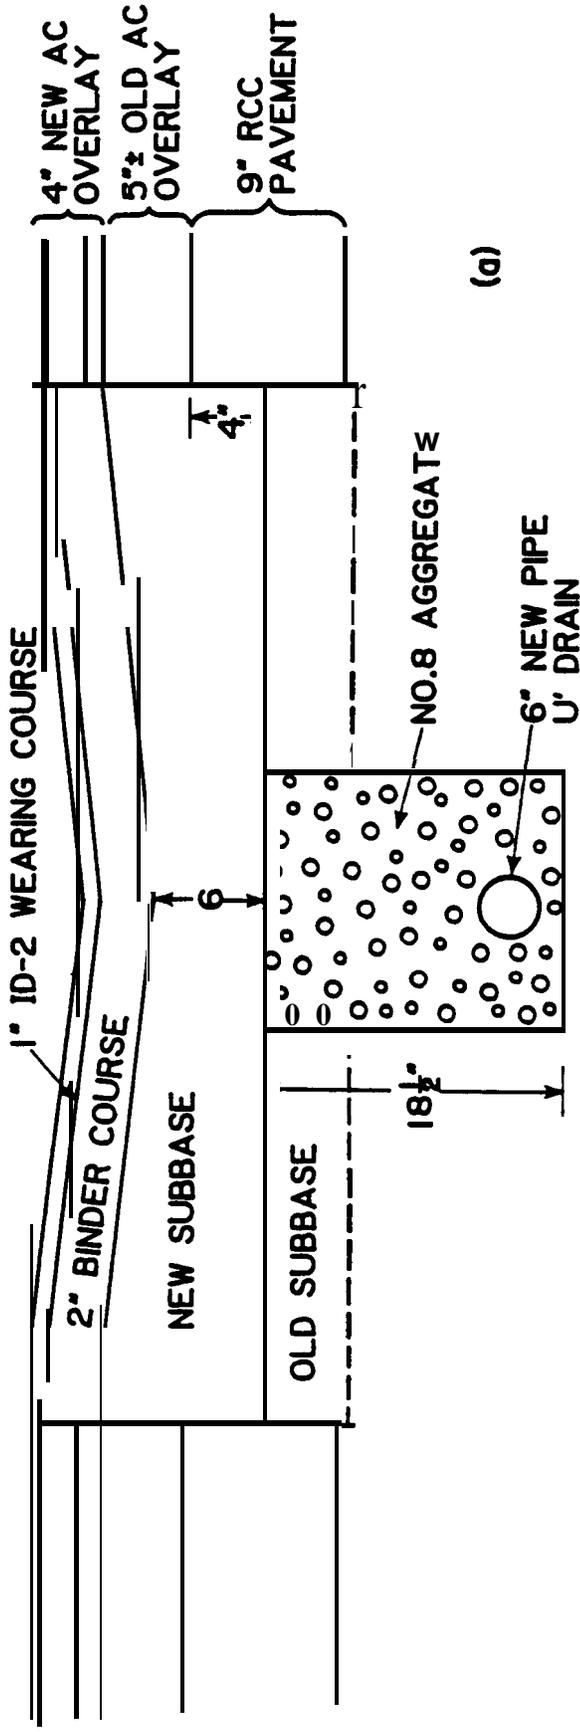
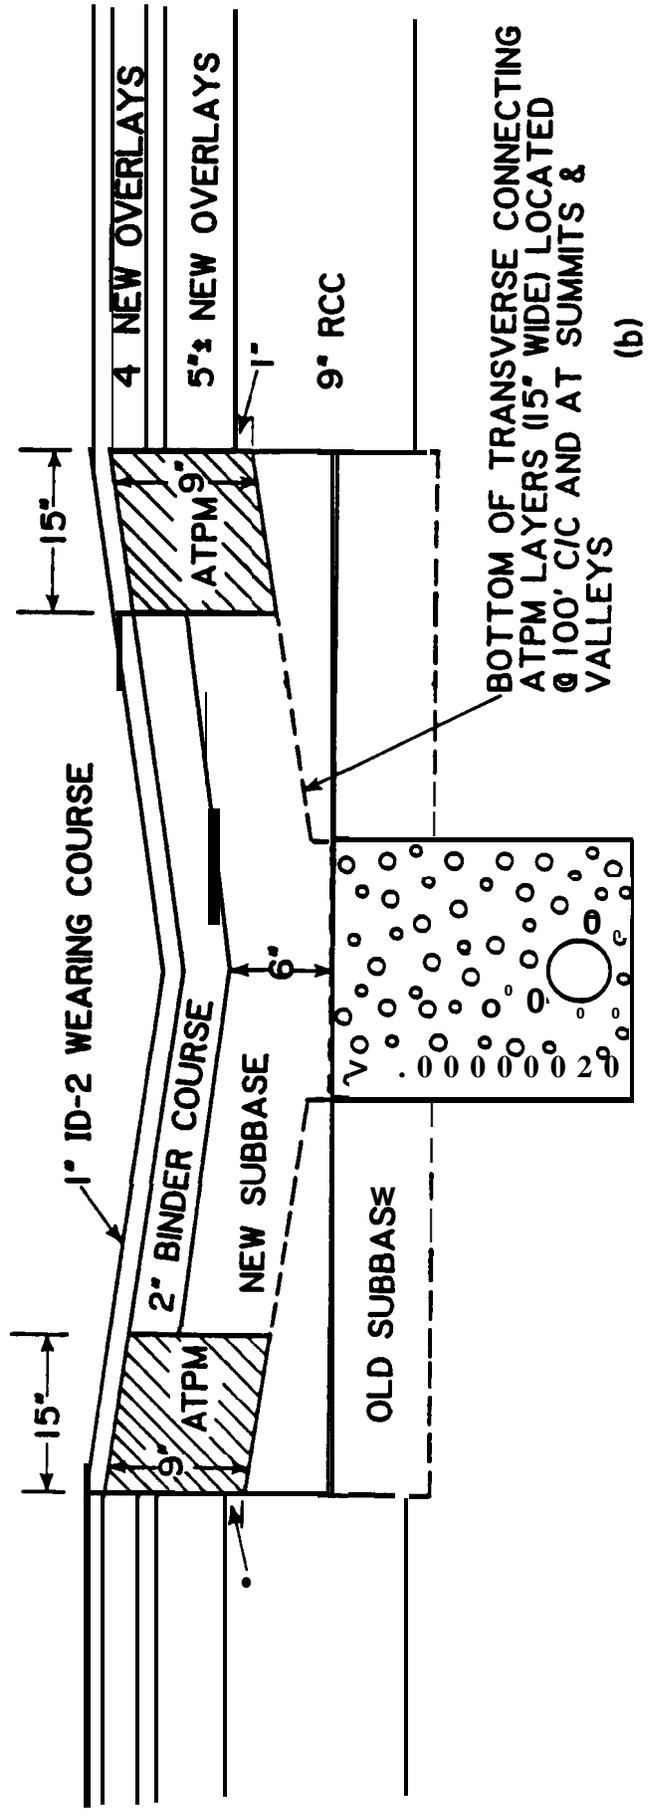
FIG. . EAST-WEST TURNPIKE TYPICAL MEDIAN SECTION
(a) EXISTING (b) PROPOSED

Visual observations (Tables 1 and 2) indicate that the pavement layers were getting water and water vapor from the subbase in the median (Figure 1a) and from the cracks and joints in the deteriorated concrete. This mechanism will be discussed in detail later.

The use of Asphalt Treated Permeable Material (**ATPM**) as discussed and recommended for East-West Turnpike earlier appears to be an excellent alternative in designing an effective subsurface drainage system for the existing as well as new

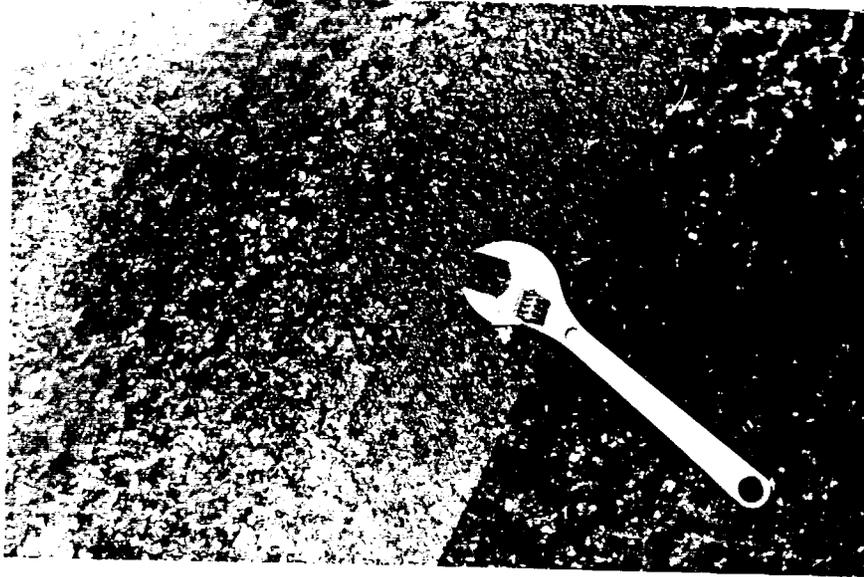
Fig. 5. East-West Turnpike (Asphalt Bubbles - One Framed by Wrench)

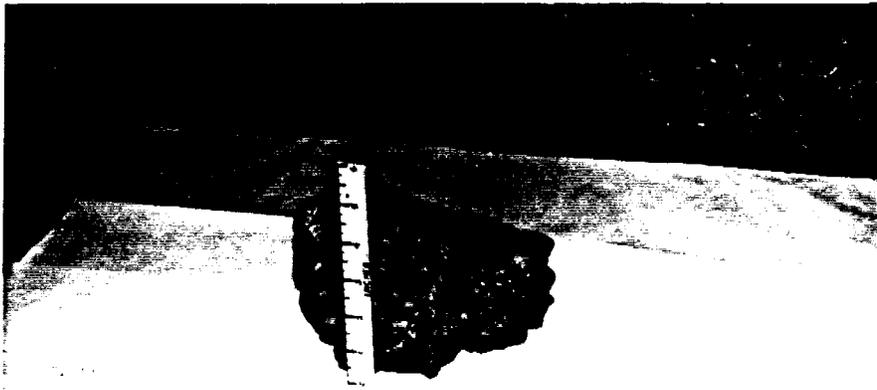
was observed at the bottom of the wearing course (Figure 6). Chemical analysis of this slurry confirmed that the suspended fines came from the coarse aggregate in the wearing course and apparently resulted from the grinding of stripped aggregate under traffic.

Fig. 6. East-West Turnpike (Bottom of Wearing Course Coated with Slurry)

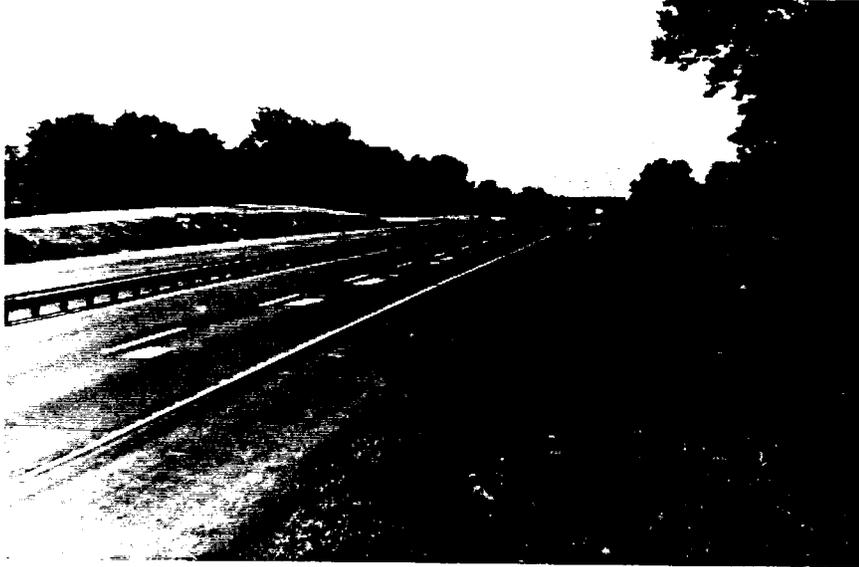
Figures 7 through 10 show the general pattern of the potholes which have been patched over the years. These pictures were taken in June 1988. Figure 10 shows three adjacent patches placed at different times. It should be noted that most of the pothole patching was done during the first two years (1978 and 1979).

Fig. 7. East-West Turnpike (General View Showing a Series of Patched Potholes on Inside Wheel Track of Slow Lane)

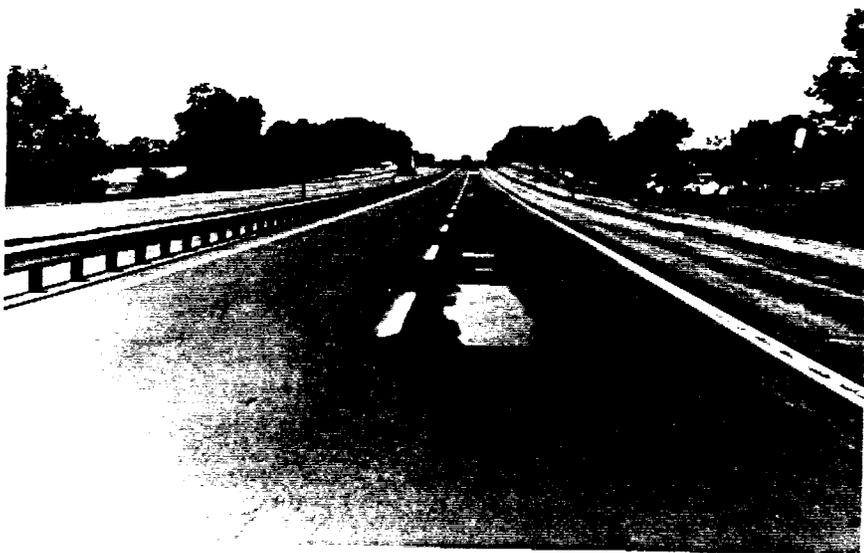
Fig. 8. East-West Turnpike (Closeup of Patched Potholes)

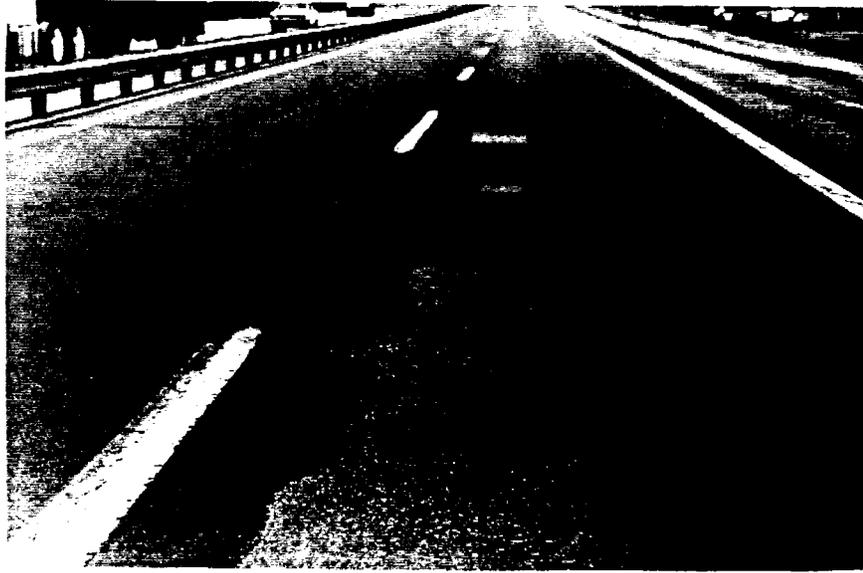
Fig. 9. East-West Turnpike (Closeup of Long Patched Pothole)

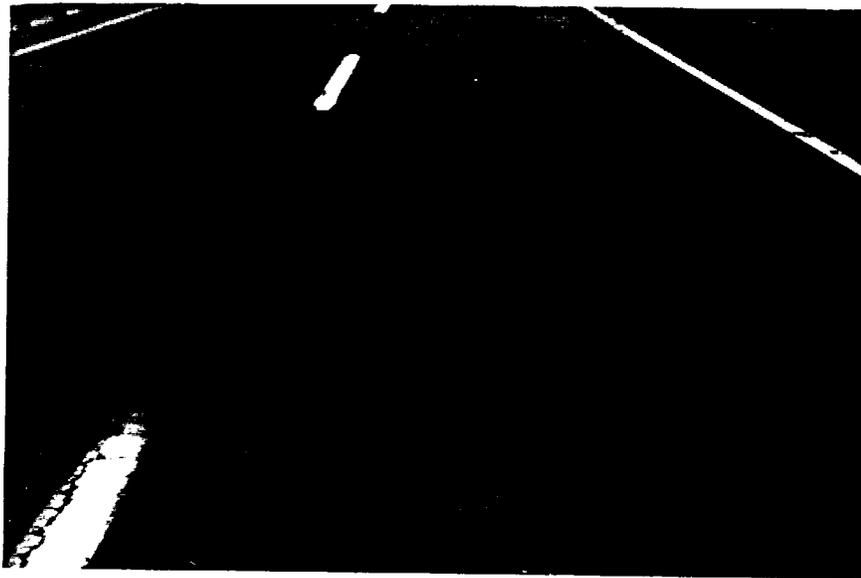
Fig. 10. East-West Turnpike (Potholes **Patched** at Different **Times**)
